**WESTERN CROSSROADS RAILWAY MUSEUM  
HISTORIC STRUCTURES SURVEY**

**DENVER & RIO GRANDE WESTERN  
CAST CONCRETE BRIDGE**

## Denver & Rio Grande Western Railroad Cast Concrete Bridge

Main Track 1 | 1600 South Street Springville Utah | 40.146171, -111.604965

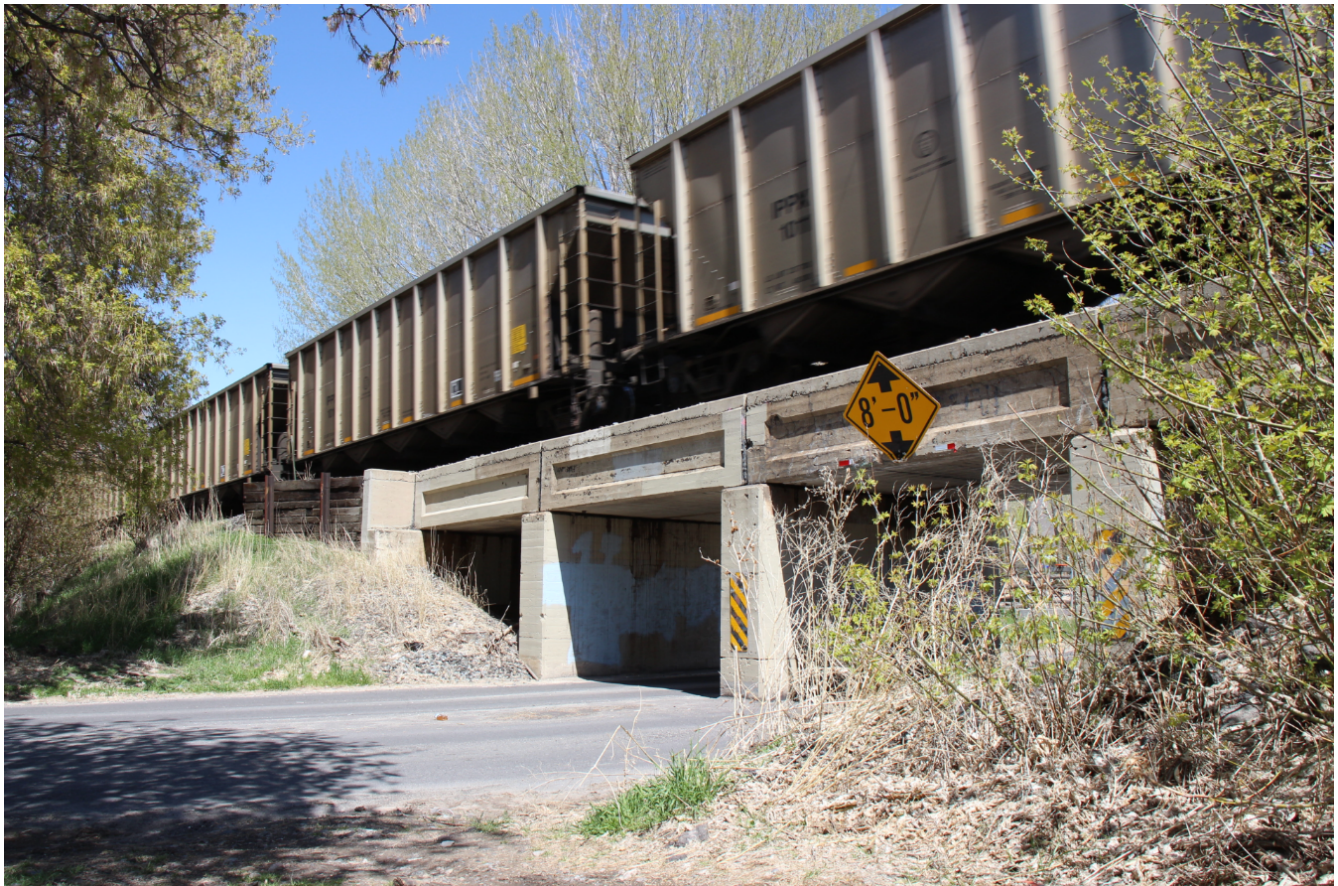
Fig. 1 West side of the bridge looking north, 18 April 2021.

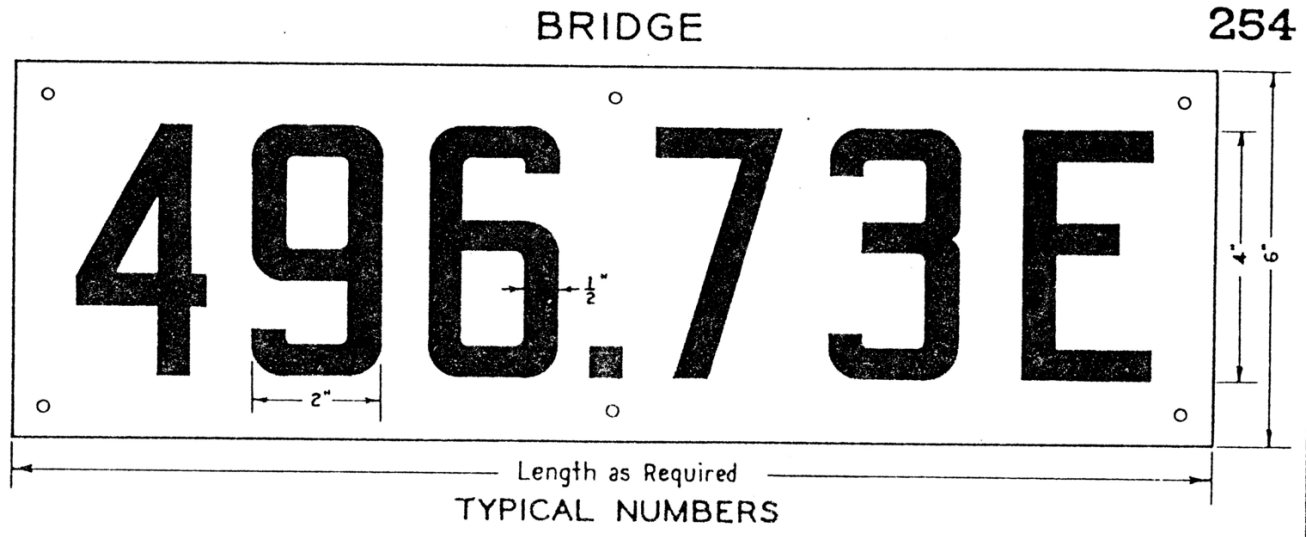
## BRIDGE NUMBERING SYSTEM

*Indication:* - Figures on the bridge number sign indicate by miles and hundredths the location of the end of the bridge nearest the mile post.

*Painting:* - Black number on white background. Dip plate in white before numbering.

*Location:* - On all open or ballasted deck bridges - timber trestles, steel trestles, girders, and trusses - without sidewalks and handrails - the sign shall be placed on the inside face of the far bulkhead where it will be conspicuous to the engineer when approaching bridge.

*On concrete trestles the bridge number shall be painted on the right end of each parapet wall in a conspicuous position when approaching bridge.*

*On through girder and through truss bridges the number shall be painted on the right end plate or the end post, respectively, in a conspicuous position when approaching bridge.*

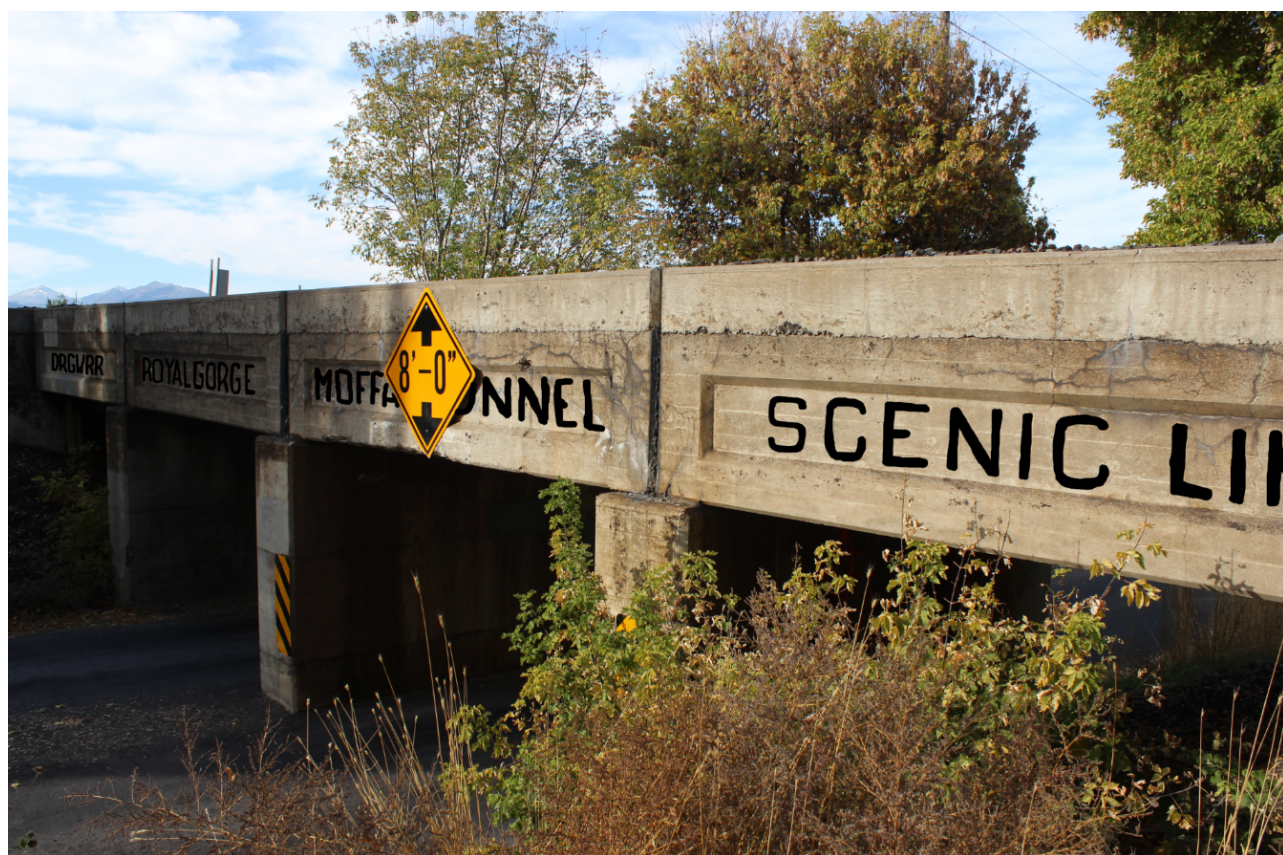
When first built, the bridge was painted with a D&RGW advertising slogan, which is now only visible under certain early morning lighting conditions in the morning on the east side. Reading “DRGWRR ROYAL GORGE MOFFATT TUNNEL SCENIC LINE,” it has been roughly traced for illustrative purposes in figure 2. Some steel girder bridges received similar slogans, so it is possible that this lettering was alike in appearance (see figure 3). At some point since the bridge's construction, the track was raised six inches, requiring 6-inch extensions to be poured on top of the bridge sections to retain the ballast. Reflective signage has been installed on the piers.

Fig.2 East side of bridge looking south in 2018, with advertising slogan digitally traced for illustrative purposes.

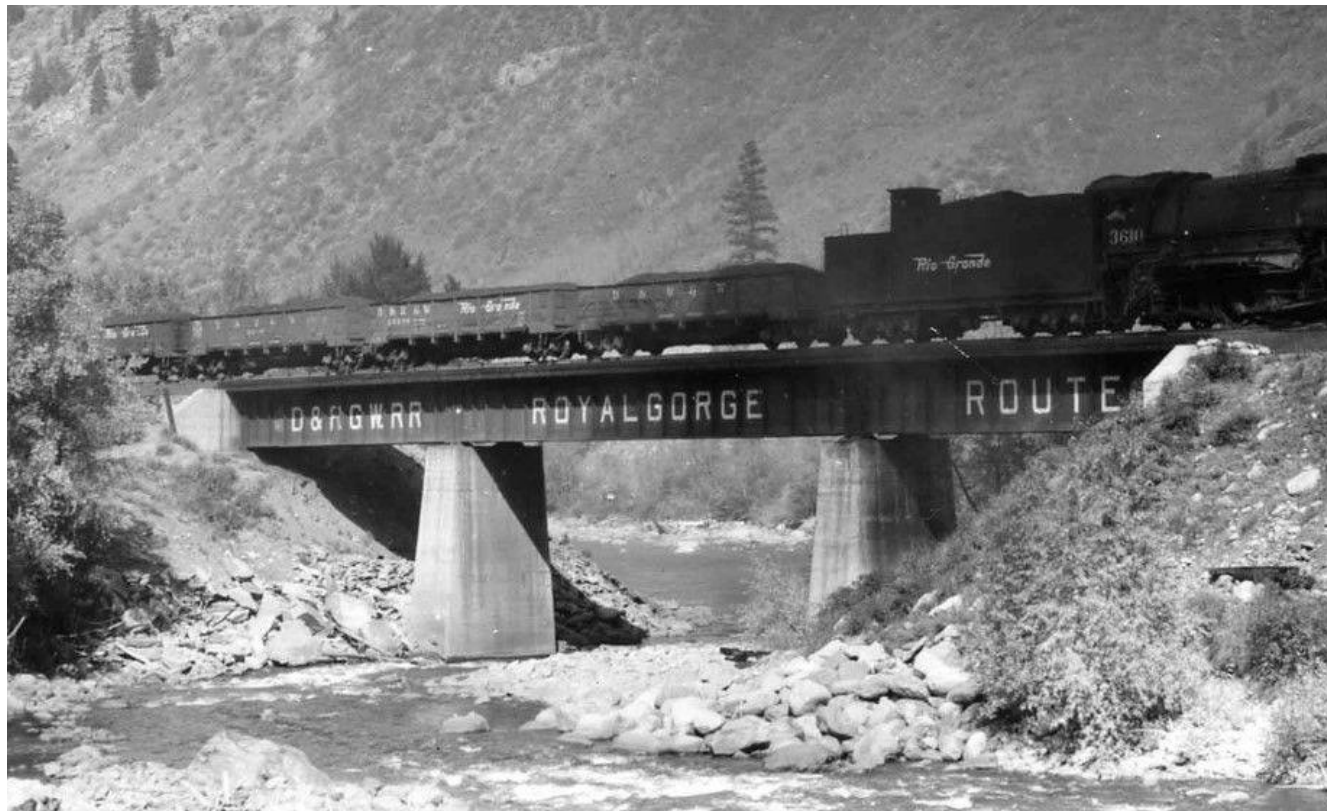
Fig.3 This steel girder bridge located near milepost 303 west of Minturn Colorado is an example of how the lettering may have appeared when still intact. Otto Perry photograph, Denver Public Library.

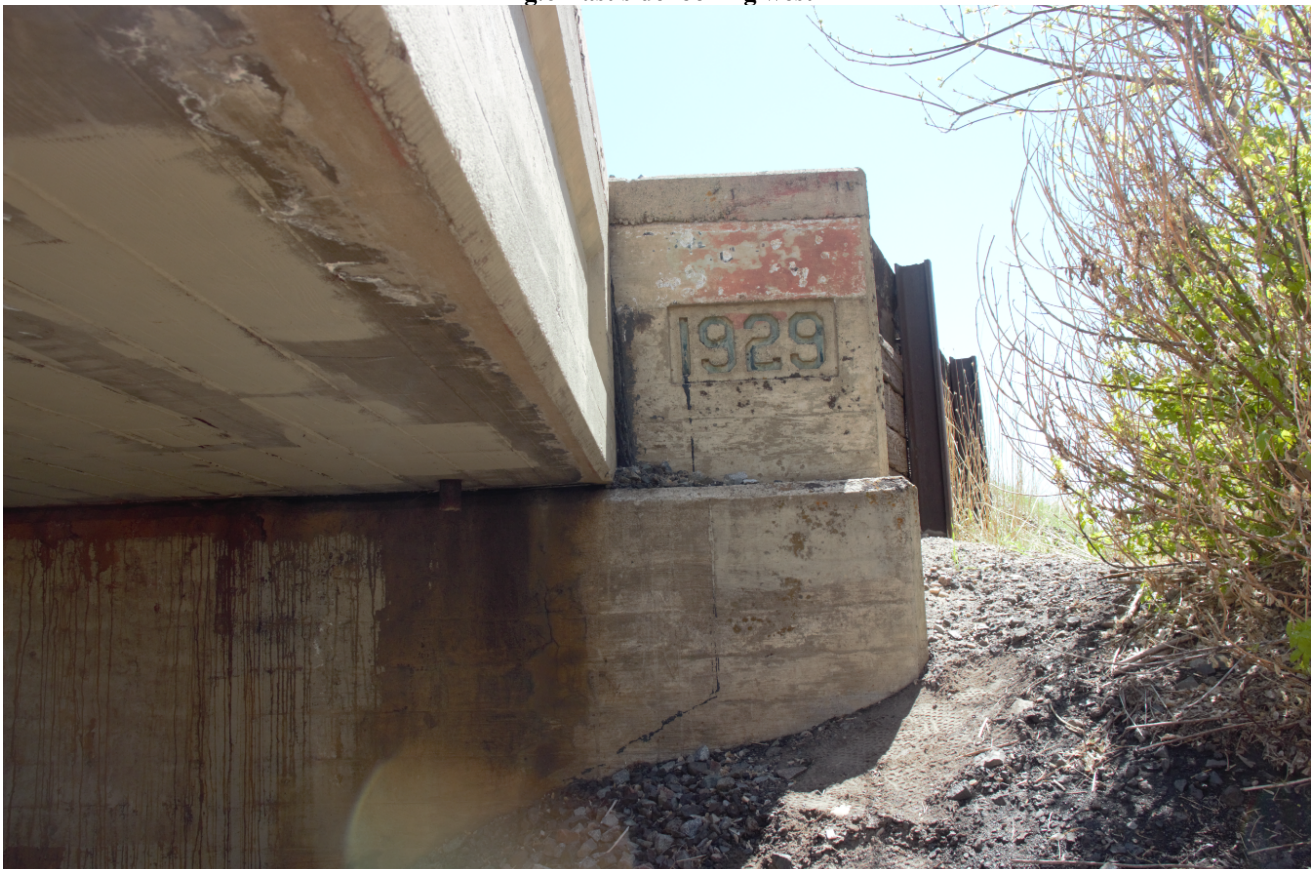
Per standard practice, the bridge is identified by its milepost. Only small flakes of black and white paint remain of the D&RGW milepost numbers, but its appearance and application can be surmised from the official D&RGW standard plans:

**Fig. 7 Southern abutment showing build date and remains of painted milepost identifier.**

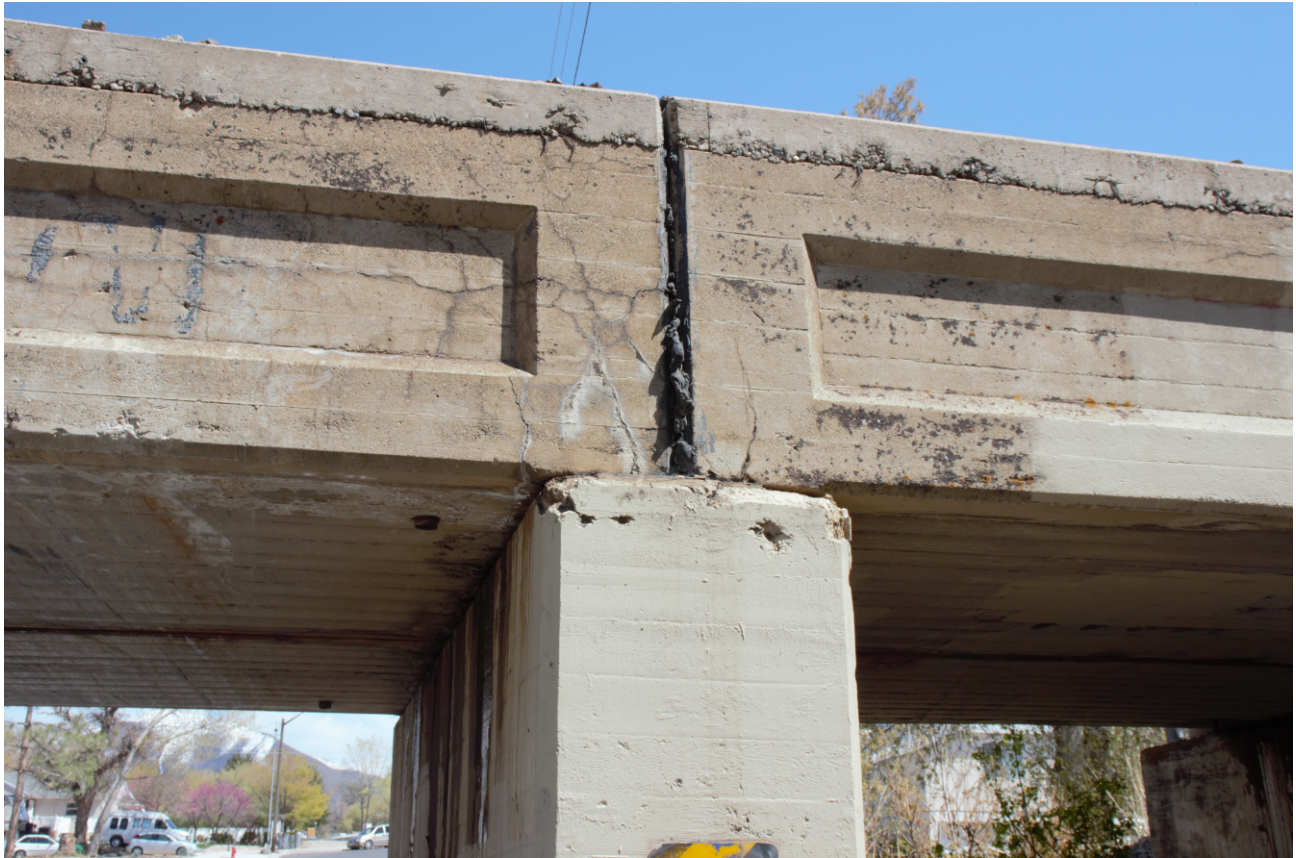
**Fig. 8 Center pier west side illustrating how the precast girder sections butt together.**

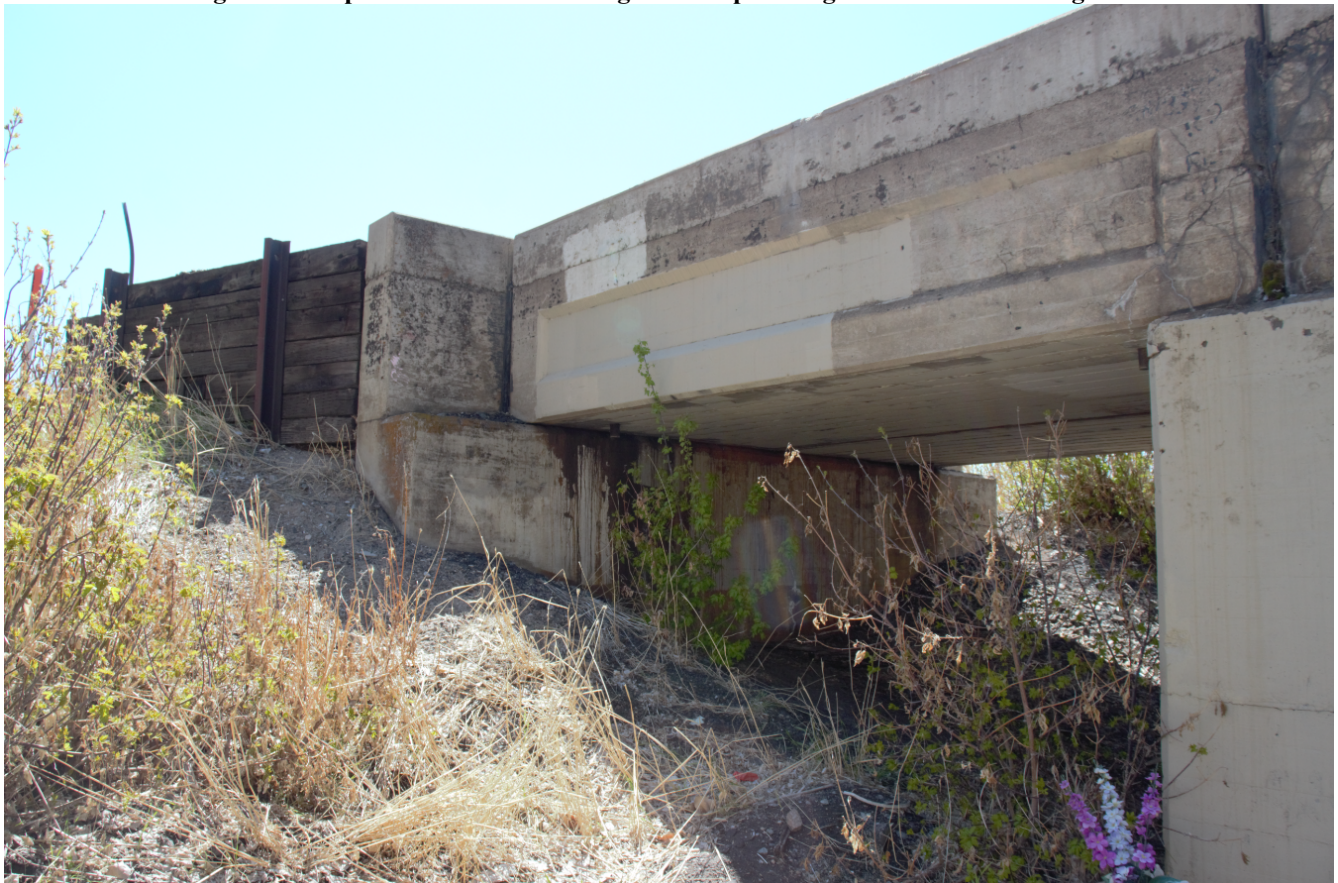
**Fig.9 Southern abutment looking southwest showing wing walls made of stacked ties.**

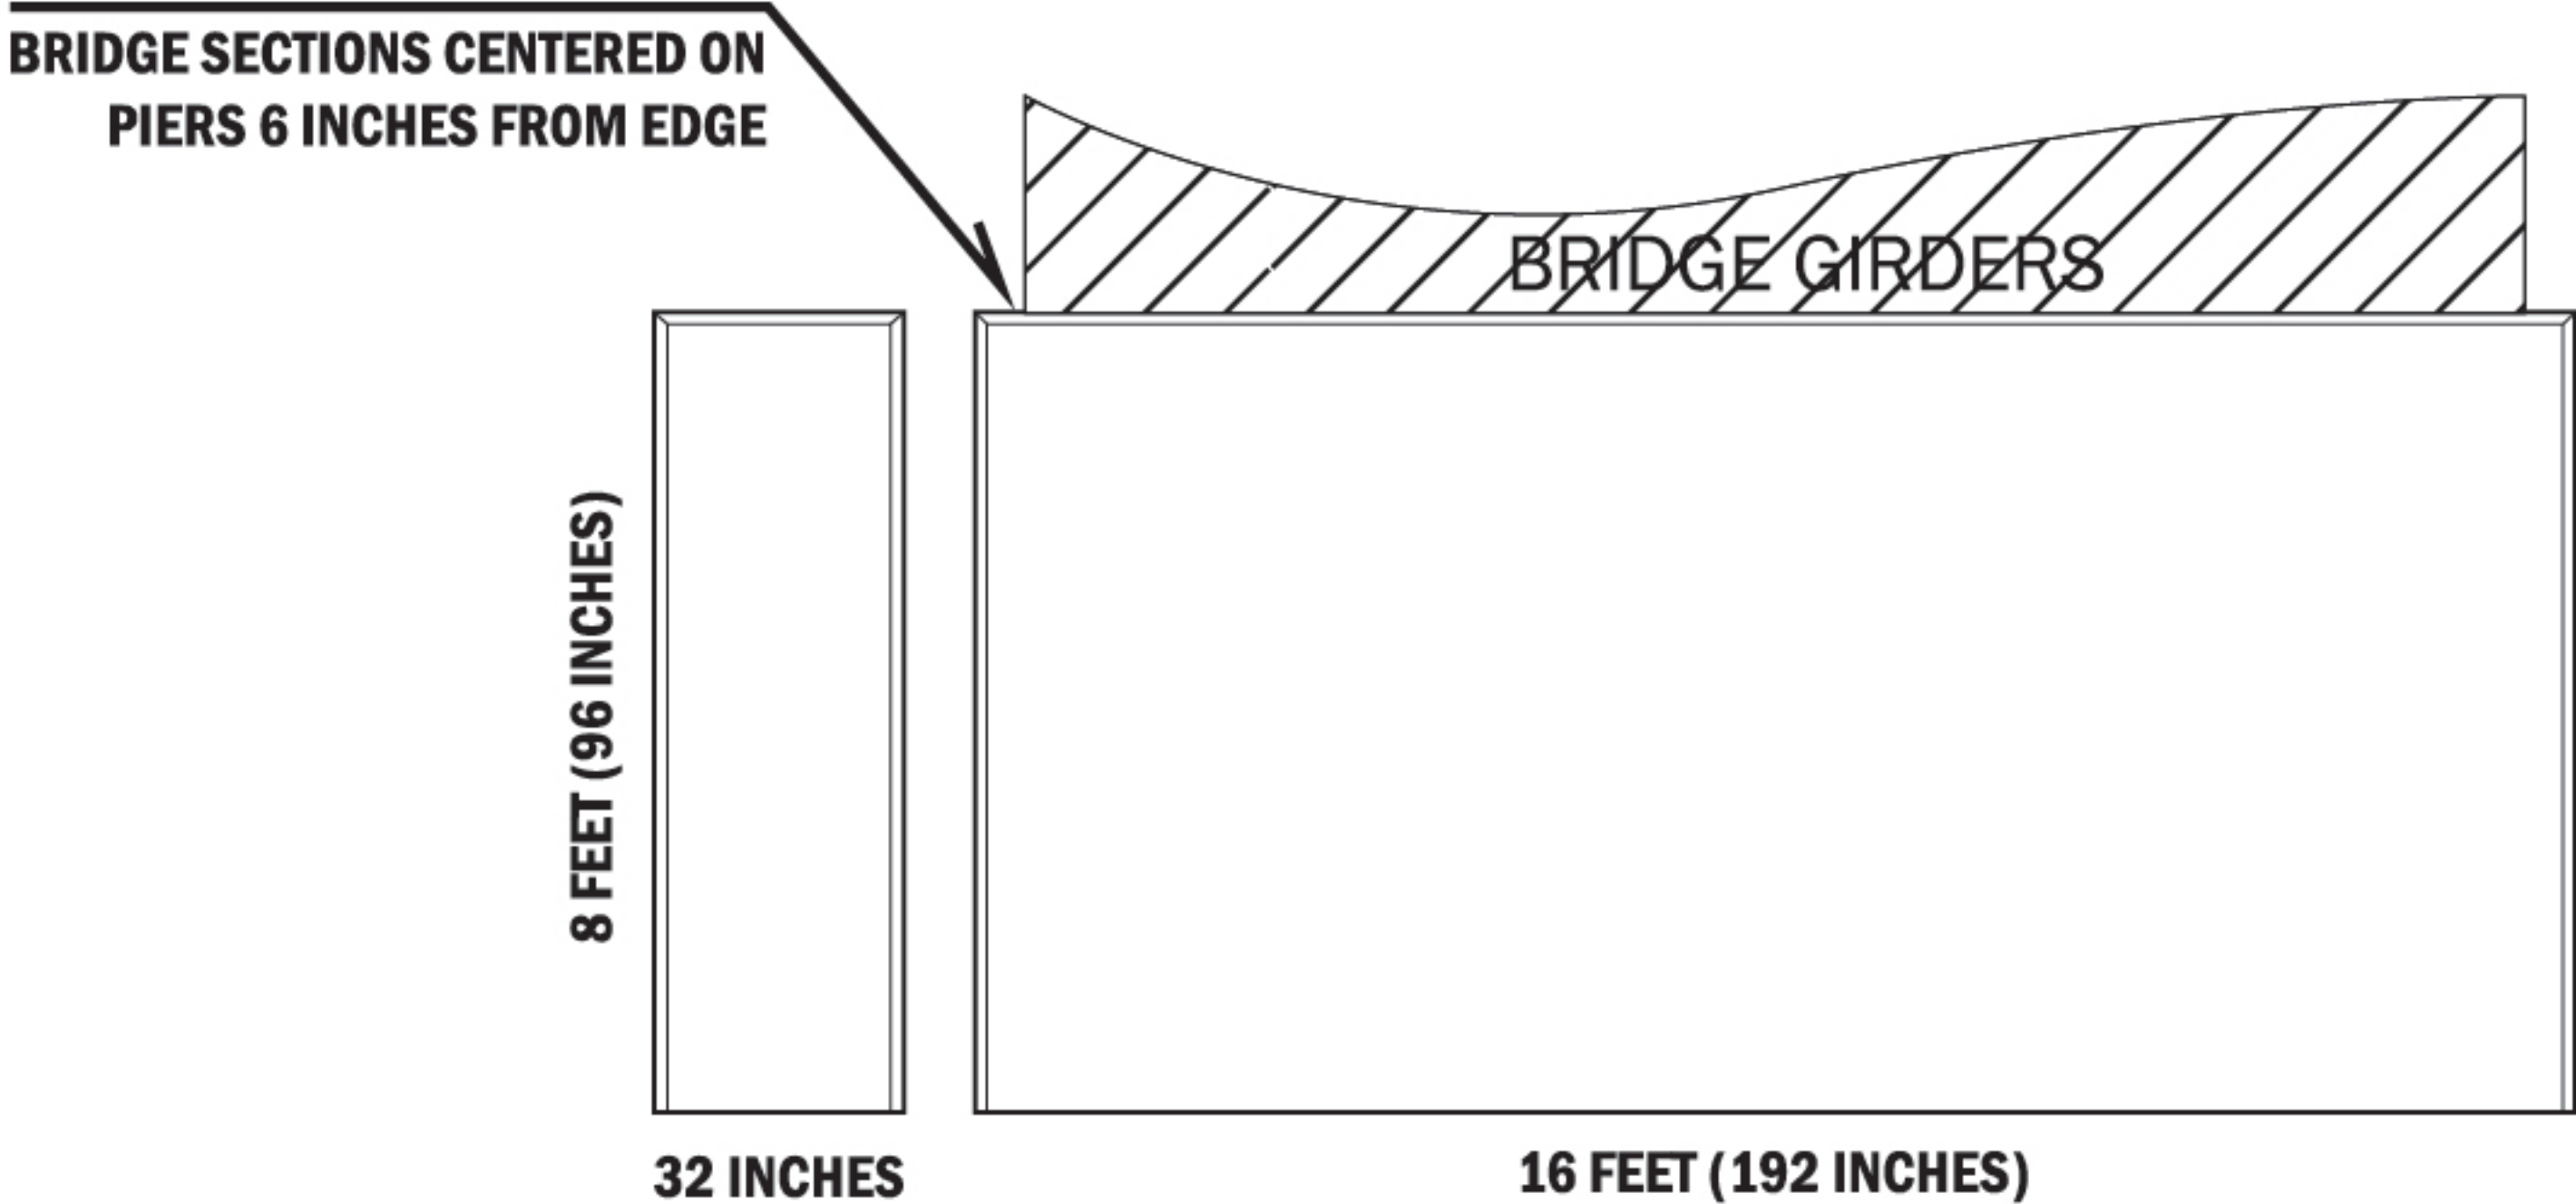
**PIERS**

ALL CORNERS HAVE A 2 INCH 45 DEGREE CHAMFER | BRIDGE SECTIONS CONSIST OF TWO HALF CASTINGS SPLIT DOWN THE TRACK CENTERLINE  
ABUTMENT AND PIER CONCRETE POURED INTO FORMS CONSTRUCTED FROM 5 INCH WIDE WOOD PLANKS

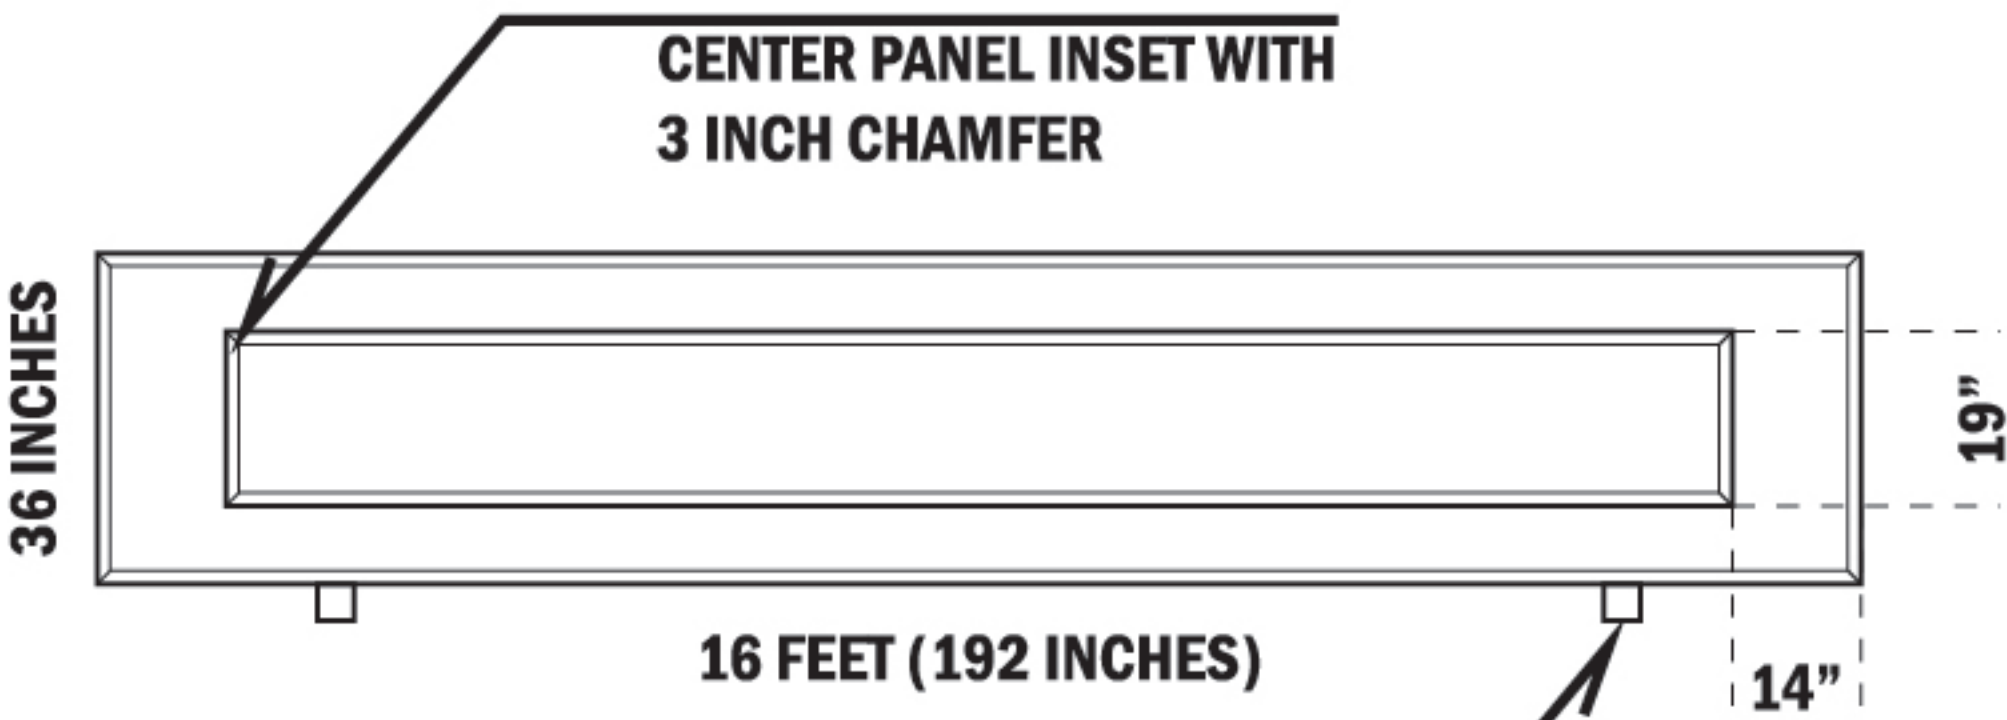
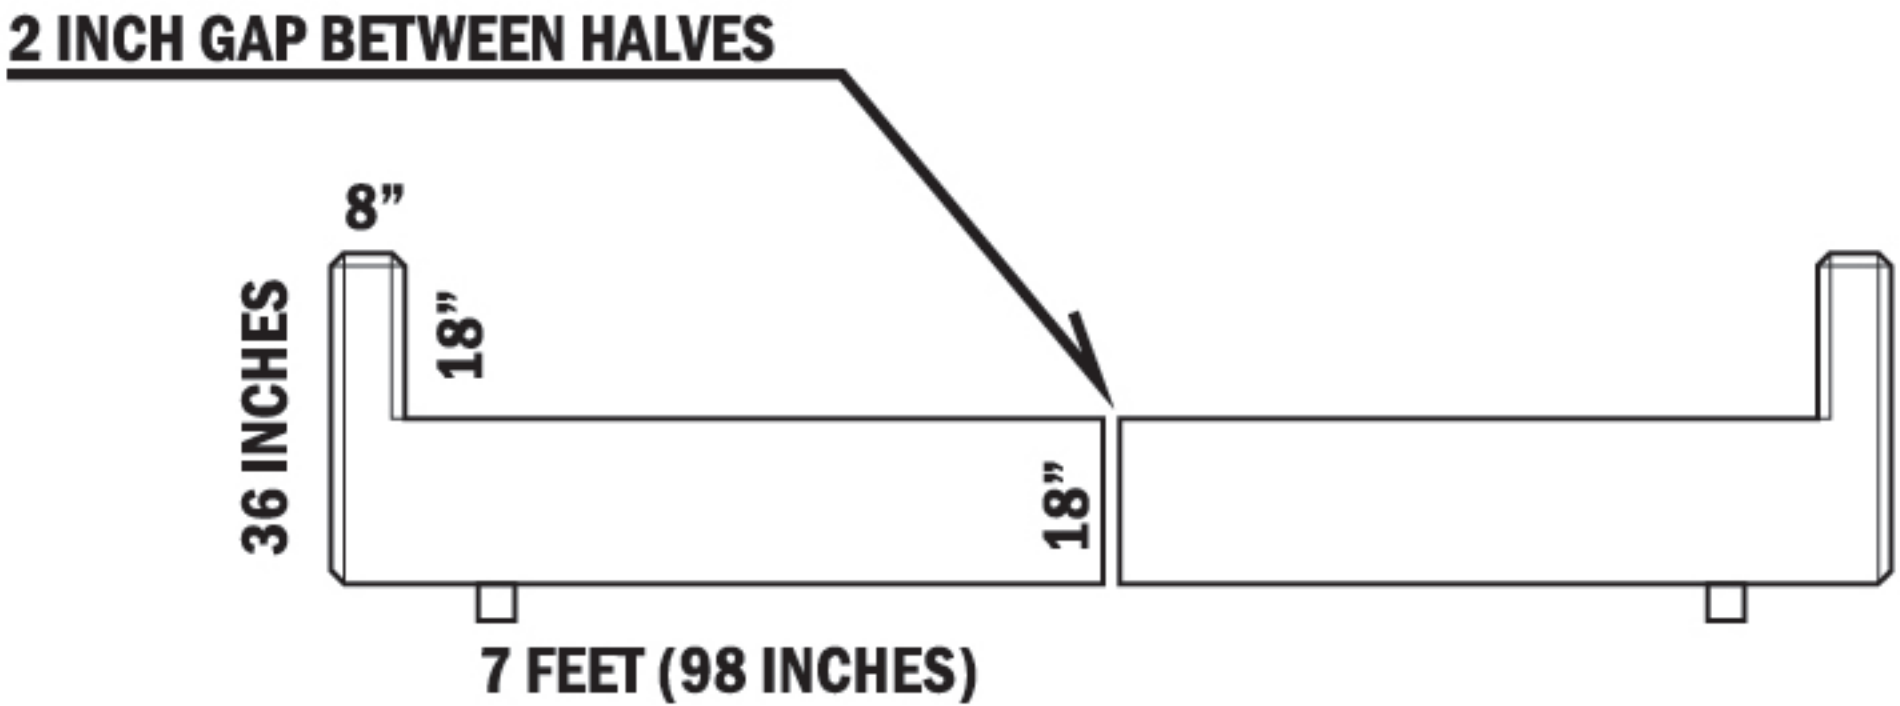
**BRIDGE SECTIONS**

4" DIAMETER DRAIN PIPES  
SET 24" FROM ENDS, 16" FROM SIDES
